Case Study: Energy Audit of the High School Dorm “Mirka Ginova”- Bitola

Vladimir Mijakovski¹, Vangelce Mitrevski² and Tale Geramitcioski³

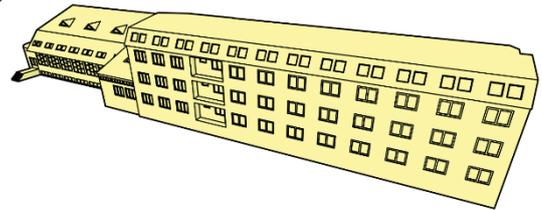
Fig. 2. Appearance of the building from the south-west

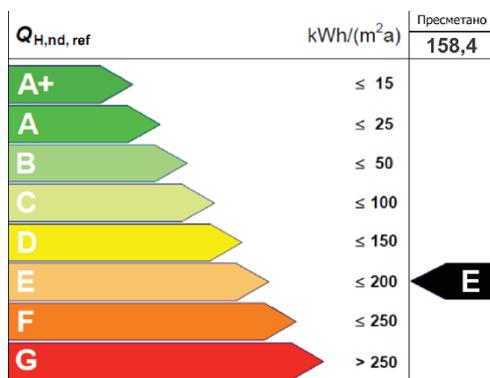
The results from the calculations categorized the building of the High school dorm "Mirka Ginova" – Bitola as class "E" building. Calculated value of energy consumption is 158,4 kWh/(m²a).

Fig. 4. Calculated energy class of the building

- Thermal insulation of all external walls in order to reach maximum allowed U-value of 0,35 W/m²K;
- Partial replacement of windows and carpentry in order to reach maximum allowed U-value of 1,7 W/m²K;
- Installation of additional thermal insulation for the roof in order to reach maximum allowed U-value of 0,25 W/m²K;
- Replacement of one of the hot water boiler running on light oil fuel with high efficiency hot water boiler running on wood pellets.
- Replacement of light bulbs and fluorescent lighting tubes with LED lights;

Implementation of these measures would 'raise' building's energy class to "C".
