FMECA Analysis of Random Mechanical Failures of a Coal System in a Surface Mine

Failure analysis; Rotor excavator; FMECA; Risk priority number (RPN); Belt conveyor; SH400.

This paper analyzes the random mechanical failures that occurred with SH 400 rotary excavators in the open (surface) coal mine in Oslomej, Kichevo, North Macedonia, for the period January 2019-2021, especially in the transport system of the excavator, referring to the data recorded by the dispatching services of the power plant. The paper deals with the failure hours and frequency of failures occurring in some subsystems of SH 400 rotary excavators and coal crushers, especially the conveyor rubber belt – their carrier structure, conveyor rubber belt, rollers, and drums. The contribution of this paper is to present the methodology for identifying potential failures before they occur, by applying FMECA as a qualitative and quantitative analysis for the coal system and calculation of the risk priority number (RPN).

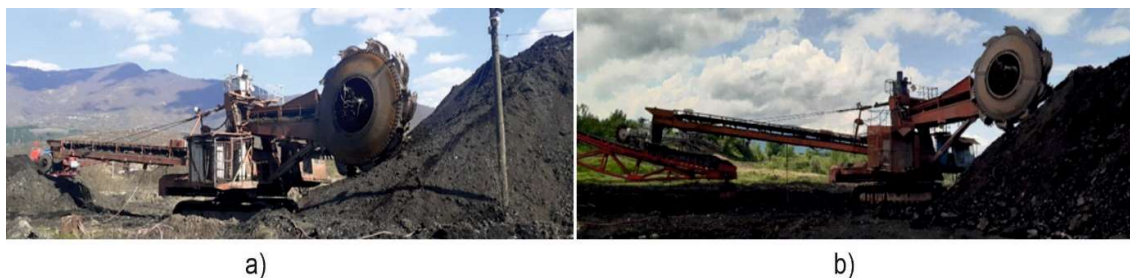
Figure 2:
a) Rotary excavator with SH 400 buckets (internally named as SH 400 /1),
b) Rotary excavator with SH 400 buckets (internally named as SH 400 /2)

Figure 2. a), shows the rotary compact excavator with buckets SH 400/1, and Figure 2. b), shows the rotary compact excavator with buckets SH 400/2, installed in the surface coal mine in West Osłomej – The Municipality of Kichevo.

The rotary excavators SH 400/1 and SH 400/2 do not work at the same time, but if possible and necessary, they can work in parallel work.

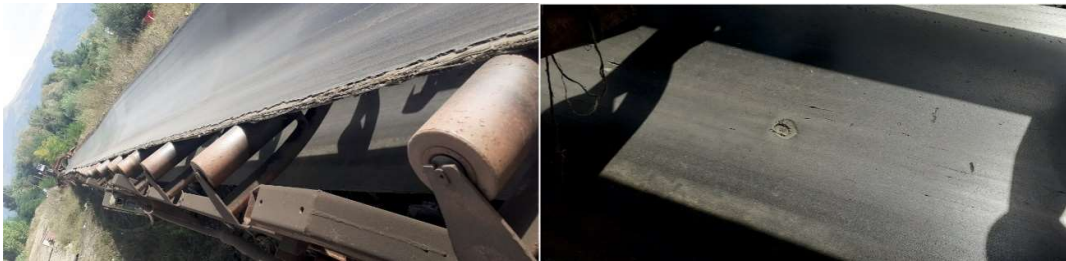
Figure 4: Damaged conveyor rubber belt

A rubber belt conveyor generally can be described as a conveyor device that uses an endless conveyor belt between two points and is an elastic part of the conveyor consisting of a core and rubber sheath [12], [13]. It is practically a bearing/working part of the conveyor which is the most expensive, the most sensitive, and the most short-lived part of the conveyor, Figure 4.

- Improper cleaning of the conveyor rubber belt from the material that is transported leads to the insertion of the material between the conveyor belt and the return belt of the drum, which causes serious damage to the conveyor rubber belt and damage to the rubber layers.

- Improper gluing of the ends of the movable conveyor rubber belt causes irregular movement on the tape, and premature damage occurs to the ends of the conveyor rubber belt.

- Uncoordinated movement and friction of the conveyor rubber belt with the construction parts quickly lead to damage to the ends of the conveyor rubber belt.

- The asymmetry of the drums and rollers can cause a complete tear of the conveyor rubber belt.
- The rupture of the bottom layer of the moving conveyor rubber belt is mainly caused by friction with the surface of the drums and rollers.

- Improper choice of material for the skeleton of the belt, which can lead to premature fatigue, tearing of textile, etc.
- Excessive belt tension causes premature fatigue on the traction side of the belt.

After changing the conveyor rubber belt or the drums, or replacing several rollers in the transport system, it is necessary to center the conveyor rubber belt.

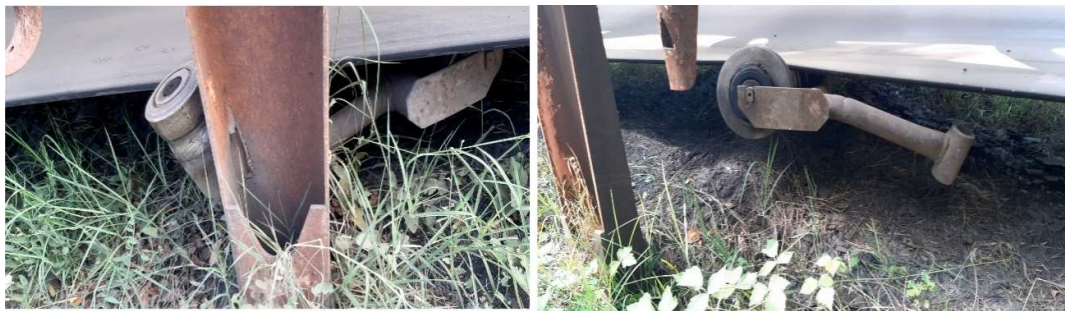
The load-bearing steel construction is an important system that connects all the elements of the conveyor into one altogether [12], [13]. The frequent failures that occur in the load-bearing construction are deformations and fractures of the steel parts from oscillations and improperly welded joints, torn bolts, displacement of the load-bearing construction due to overloading and subsidence of the ground from underground water, possible fires from the electrical installation, or from the strong friction of the conveyor rubber belt with the steel rollers or the rubber drums, Figures 6.

Figure 6: Parts of the load-bearing steel construction in an improper condition due to cracks and fractures from mechanical impacts, installed in the surface mine Oslomej West – Municipality of Kichevo

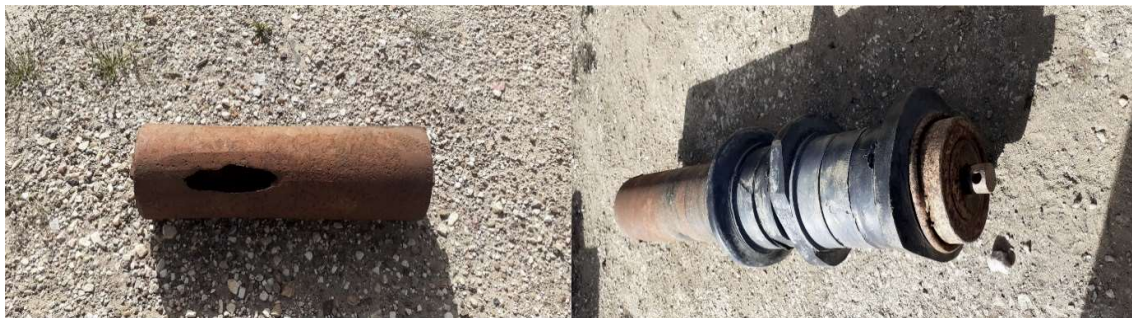
Figure 8: Damaged rollers

There are many different causes of roller failure, but the most common causes are abrasion, corrosion, seal failure, and total roller destruction. Regular attrition or friction of the surface, from contact with the conveyor rubber belt, can limit the cohesion of the rollers. In this case, corrosion is directly related to abrasion, and the more corrosion there is, the greater the rate of abrasion and the weakening of the surface of the material. In this case, the corrosion is related to the abrasion, the more corrosion there is, the higher the abrasion rate, and the weakening of the surface of the material is accelerated.

Roller failures may also occur due to tearing of the roller body, blocking of the bearings on which the roller leans, and broken axis of the roller, which damages are recognized by the sounds that are produced and the oscillations that appear, as in Figure 8. These roller conditions can result in catastrophic damage to the conveyor rubber belt, manifested by cutting and tearing of the conveyor rubber belt.

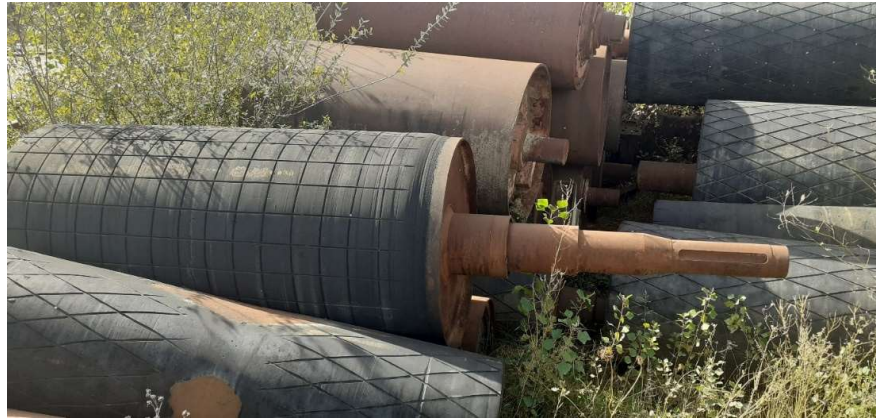
Figure 10: Damaged drums

The drums are the sensitive parts of the conveyor rubber belt, they transmit the traction force of the conveyor rubber belt and enable the movement of the conveyor rubber belt. The drums consist of two bearings, a shaft, a body, and a wrapper [5], [13] Figures. 10.

The cracks that occur in the drums appear as a result of strong impacts and actions during the work process and from the friction that occurs between the rubber lining of the drum and the conveyor rubber belt.

Failure of the drums also occurs from frequent fractures of the drums bending and twisting of the shafts as a result of dynamic strikes, the action of overloads than allowed, and other actions in machine parts such as solid materials getting between the conveyor rubber belt and the drum lining causing serious damage up to system failure.

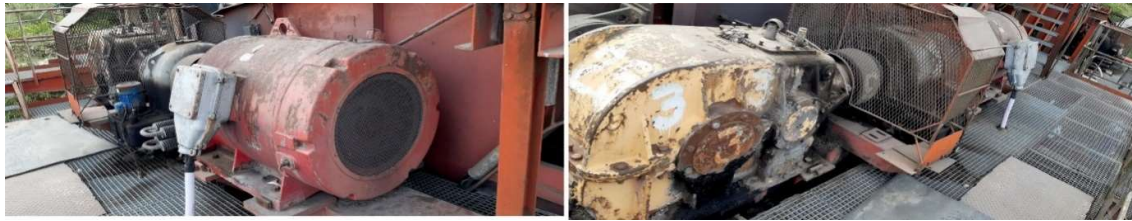
Figure 12: Damaged electric motor and reducer of the coal collection station marked as Js-3

In the period from 2019 to 2021, no failures were registered due to the failure of engines or reducers from the coal system. Figure 12 shows a damaged electric motor and reducer from the coal system but in a period outside the analyzed period of failures.

According to the information from the expert team in the coal sector, this system of the power plant did not stop during the period from 2019 to 2021 electric motor did not fail, and neither did the reducer due to regular maintenance (corrective, combined, and preventive), so the assessment is $RPN = 50$ for the electric motor and $RPN = 40$ for the reducer. In Table 9, the value for $RPN = 280$ for the electric motor and the value for $RPN = 180$ for the reducer are predicted values by the expert team in cases where these two main elements would lack proper and timely maintenance.
